Manhole Inspection Summary

Manhole # S11GG_041MH

Insp Date: **11/2/07 12:15 PM**

Location Address: **3018 GRAYSON ST**

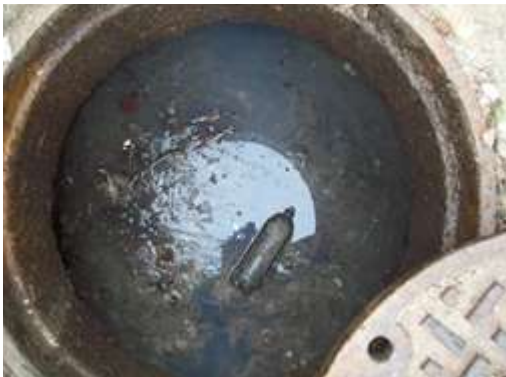
ACTIVE SURCHARGE

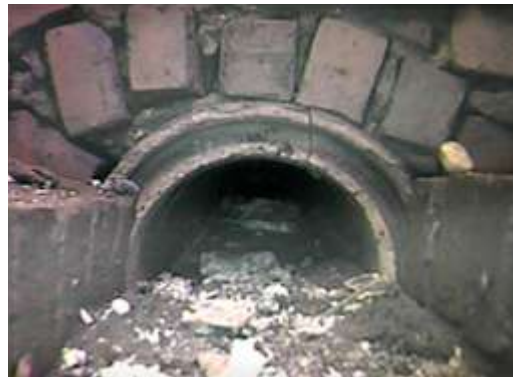
Defect 1

Condition: ☐ Sound ☐ Cracked ☐ Root Intrusion ☐ Deteriorated ☐ Leaks ☒ **Debris**

CHANNEL DEBRIS

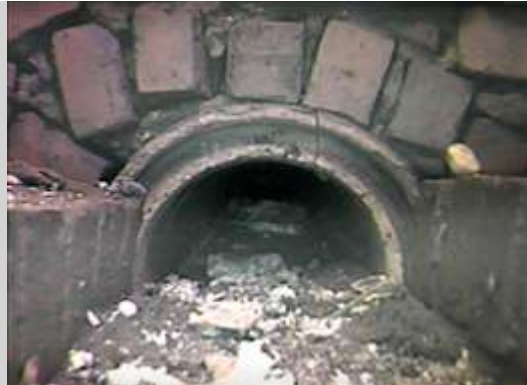
12 O'Clock Outflow

PIPE CRACKED AND LOTS OF DEBRIS IN CHANNEL.

Infiltration: **None** Pipe Seal Cond: **Cracked**

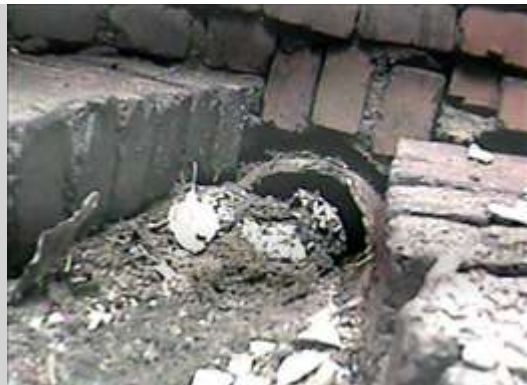
6 O'Clock Inflow

CAN'T EVEN SEE PIPE TOO WELL BECAUSE OF THE MASSIVE AMOUNT OF DEBRIS IN CHANNEL.

Infiltration: **None** Pipe Seal Cond: **Cracked**
